## Application of NDT Thermographic Imaging of Aerospace Structures

PII: S1350-4495(18)30956-3  
DOI: <https://doi.org/10.1016/j.infrared.2019.02.002>  
Reference: INFPHY 2858

To appear in: *Infrared Physics & Technology*

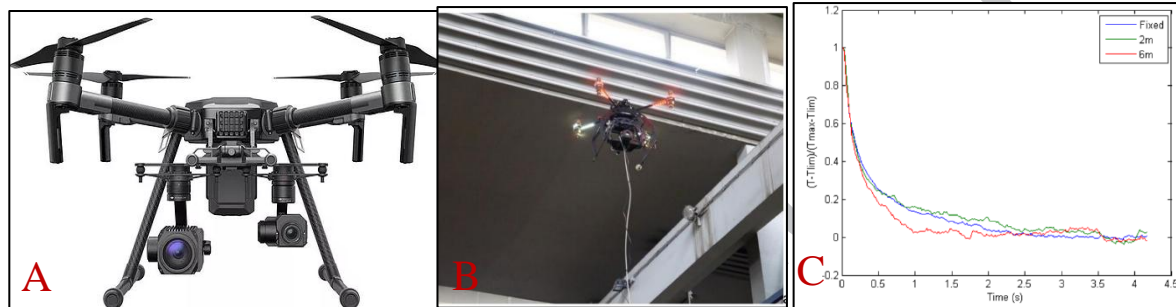
**FIGURE 20 A:** DJI M210 equipped with thermal camera [27]. **FIGURE 20 B:** UAV equipped with thermal camera [12]. **FIGURE 20 C:** Comparison of front face temperature responses to flash heating in the case of a large uniform irradiation with a fixed camera and a stabilized camera with UAV at two distances (2 m and 6 m) [12] [5].

Along with the liquid penetrant NDT method as mentioned in the introduction, a UAV thermographic inspection was tested for civil engineering applications (see Figure 20B). The UAV is equipped with a FLIR A320, this IR camera is connected to a computer via a cable, one is a power cable and the other provides real time radiometric thermal images, which will reveal heat patterns and thermal anomalies [12]. Transient thermography with flash and step heating where the methods used in this inspection. An inspection took place and gathered data on different distances between the camera and the samples (2, and 6 metres). Along with the UAV equipped with the IR camera, there was a fixed IR camera, therefore two sets of data could be acquired and compared. A thermally uniform area of a sample is delimited, and the IR cameras captured the data [12] [5].
